# Testing UAVs to perform aerial photographic survey of harp and hooded seals in the West Ice area

SURVEY REPORT – KV “SVALBARD” 16-26 MARCH 2014

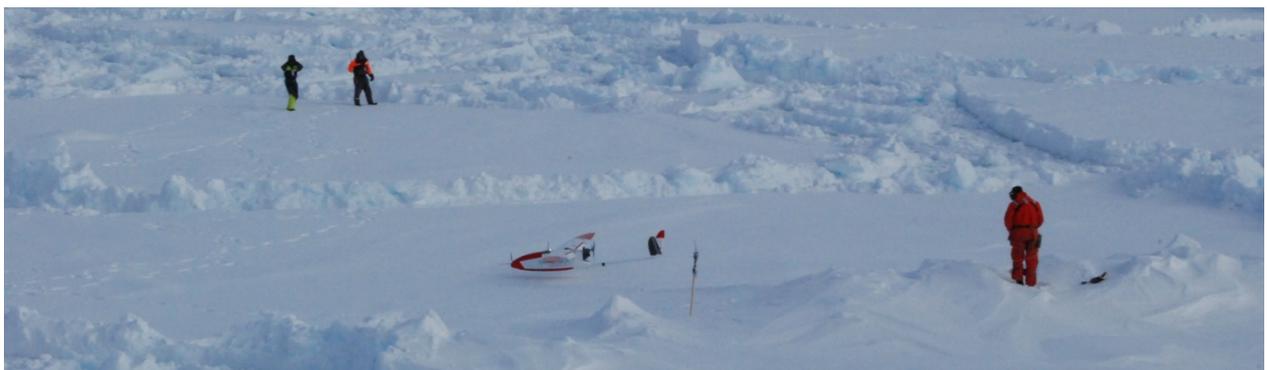
**Figure 2.** Kjell-Sture Johansen is landing CW1 on a small ice floe. Photo: S. Solbø, Norut

The CW1 airframe is produced by ET-Air S.R.O in Slovakia. Final assembly was done by Norut. The main airframe structure is fiberglass composite made using CNC (Computer Numerical Control) routed molds. The propulsion is a Zenoah G62, a 62cc two-stroke petrol engine, running on 95 octane petrol with a 2% oil mixture. The plane is equipped with Iridium modem and beyond radio line of sight range is only limited by fuel amount and battery capacity for powering avionics and payload. Up to 3 hours operation is possible in good weather. High wind and cold weather will reduce range. The aircraft is launched by pneumatic launcher from the ship deck, and needs adequate ice surface to land on.

The CW1 can be safely operated in wind speeds up to 15 m/s. During the survey in the West Ice we experienced wind that was above the safe limit, and we had to wait for acceptable conditions. Another problem is the need for pre-heating of the engine before it can be started in low temperatures. The low temperature is also affecting the useful capacity of the onboard batteries. Another limiting factor to consider when using the CW1 is the need for adequate landing areas. It is preferable with an ice sheet that is more than 80x20m for a safe landing.

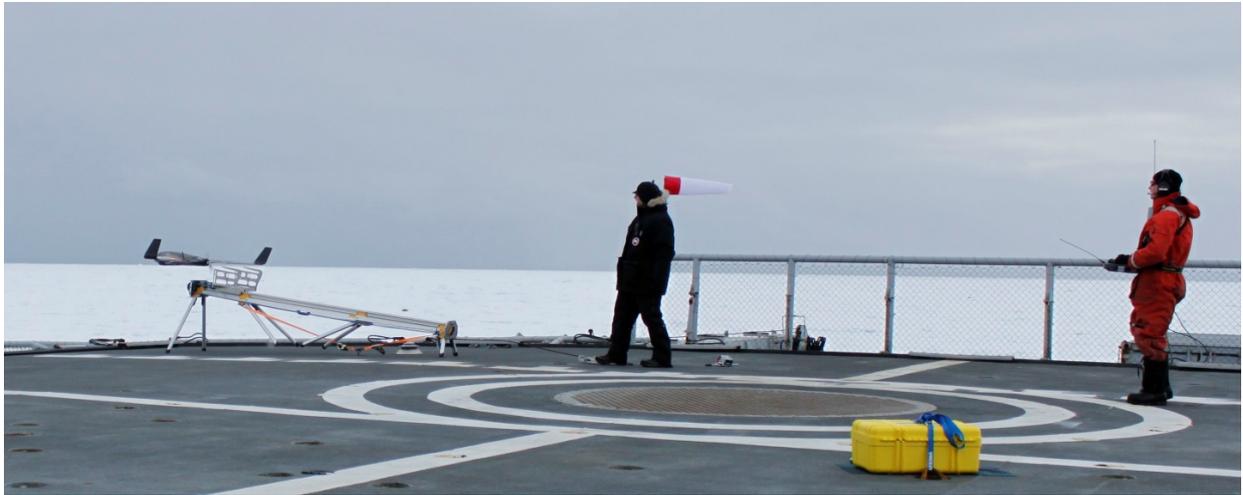
**Figure 3.** Take-off CWM from the KV “Svalbard” Helicopter deck, 19. March 2014. Foto: D. Stødle, Norut

The CWM airframe is produced by Skywalker Ltd. Final assembly was done by Norut. The main airframe structure is EPO, (Expanded PolyOlefin) a type of crash resistant foam which is carbon fiber reinforced. The propulsion system is electric and maximum airtime between charge/change of battery is 40 min. This aircraft is only equipped with line of sight 433 MHz radio modems and can therefore

only be used for within a 10–20 km radius (range depend on antennas used for tracking and radionoise in the area). The aircraft is launched from the ship deck with a bungee catapult launcher. If the deck is large enough (like on the helicopter deck of KV Svalbard), it is possible to land the aircraft on the deck, or into a net mounted on the deck.

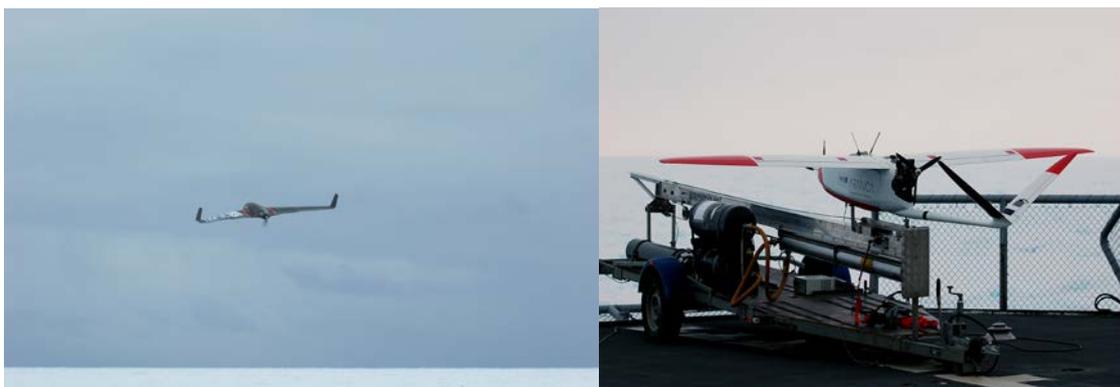
**Figure 4.** Left: CWM in flight. Right: CW1 ready for takeoff. Photos: M. Poltermann

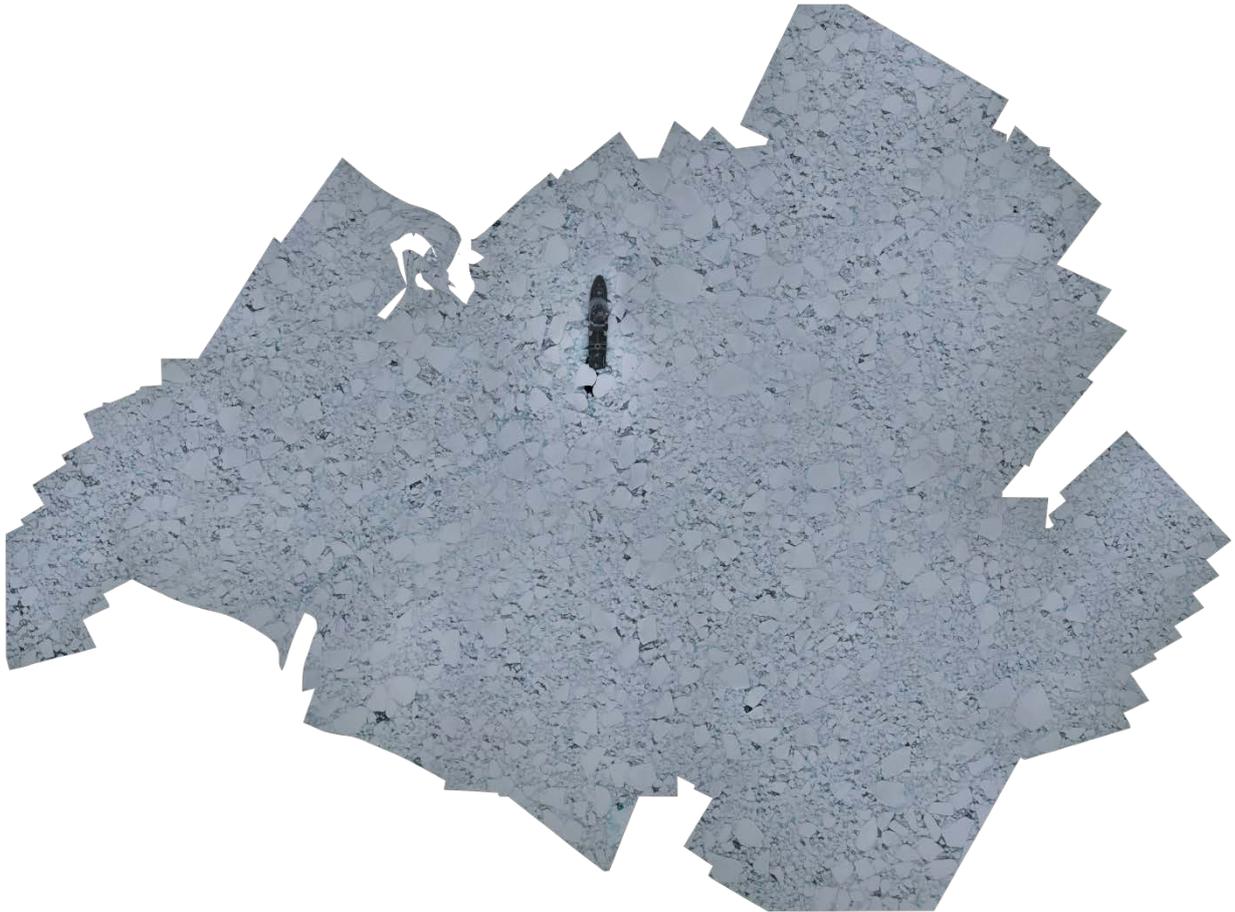
**Figure 6.** Mosaic from CWM flight on the 19 March. As the flight was mainly flown in manual mode due to airspeed sensor issues no structured grid was flown. The mosaic is based on 300 images from a 15 minutes flight.

To generate a mosaic (Figs 5 and 6) for each flight transect, the corresponding images are stitched together in a process that aligns unique key-points in overlapping images. The commercial software package Agisoft PhotoScan is utilized to perform this task. This mosaic image is geo-referenced and can be imported into GIS software (Solbø and Storvold 2013; Stødle et al. 2013).

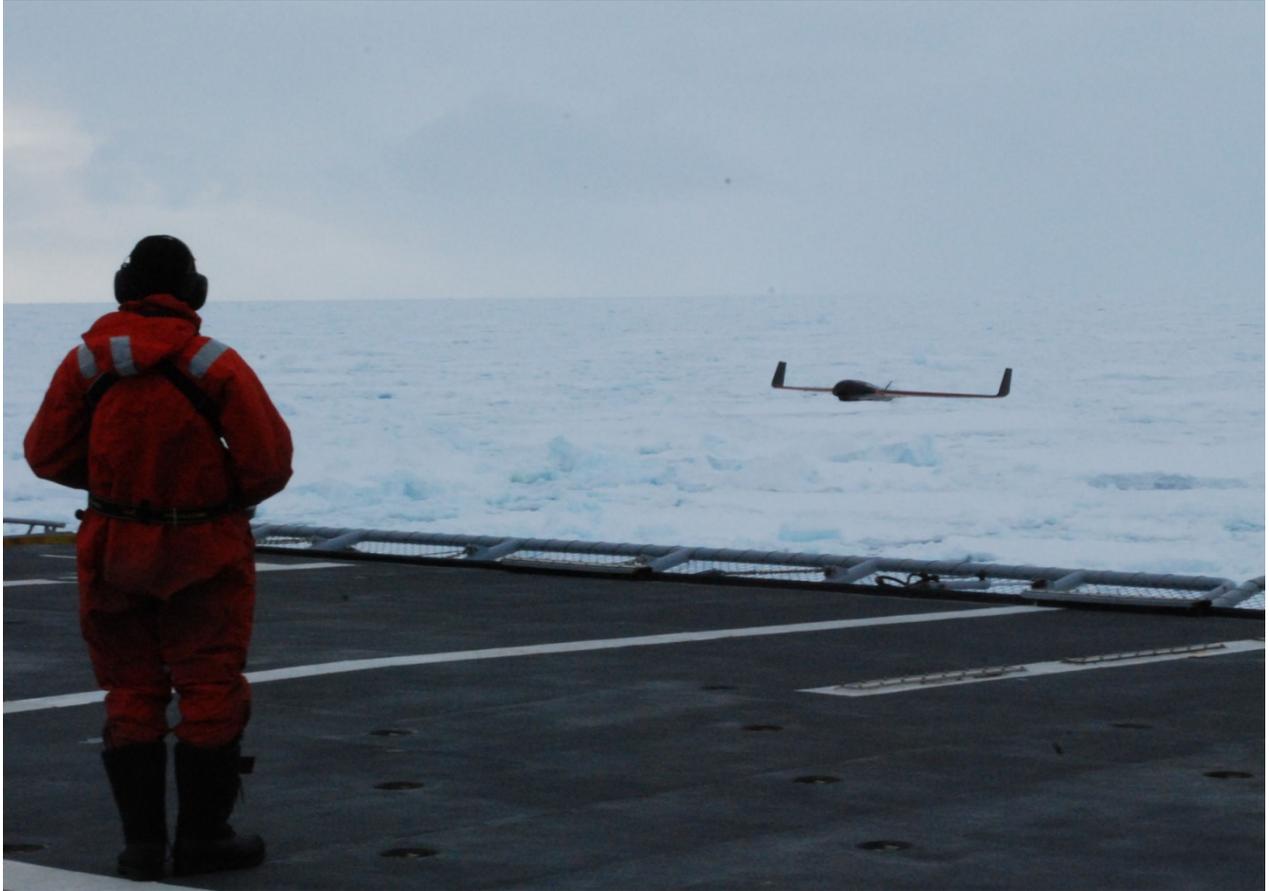
**Figure 12.** Kjell-Sture Johansen is performing a manual landing of the CWM on the KV “Svalbard” helicopter deck on 19 March. Photo: S. Solbø, Norut.

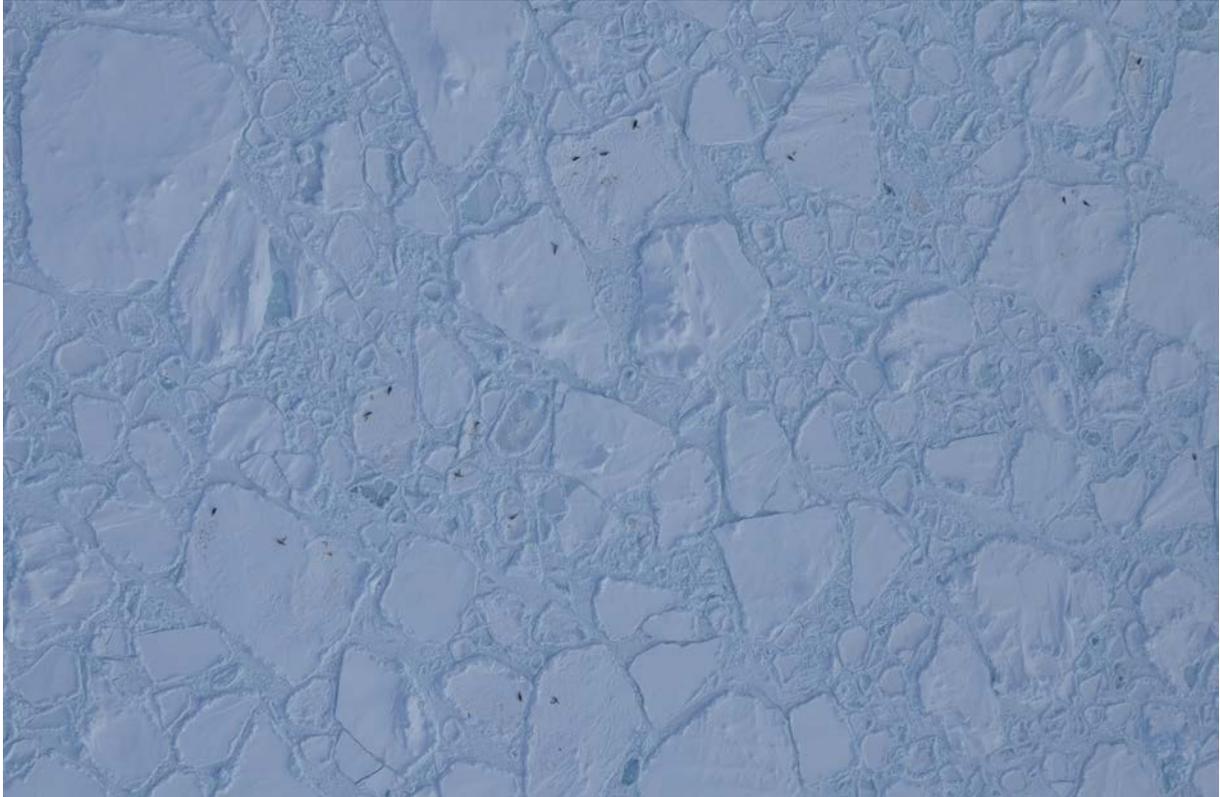
**Figure 13.** Image from CW1's Nikon D5100 Camera with a 35mm lens at 300 m altitude taken on 22 March.

The CW1 was instrumented with a 16 bit, 640x480 pixel ICI-7460 uncooled bolometer IR camera from Infrared Cameras Inc, and a Nikon D5100 16MPix SLR Camera with a 35mm lens. Metadata on aircraft attitude (orientation) and position were collected using an Xsens MTI-G IMU at 100 Hz and a Holux GPS. The IR camera was programmed to take one image per second, while the Nikon camera was programmed to take one image every 2 seconds (maximum speed). The sensors were controlled by the onboard Linux PC and data collected were stored on a solid state. With a flight altitude of 300 m, which was used on March 22, the footprint is about 180 m wide.

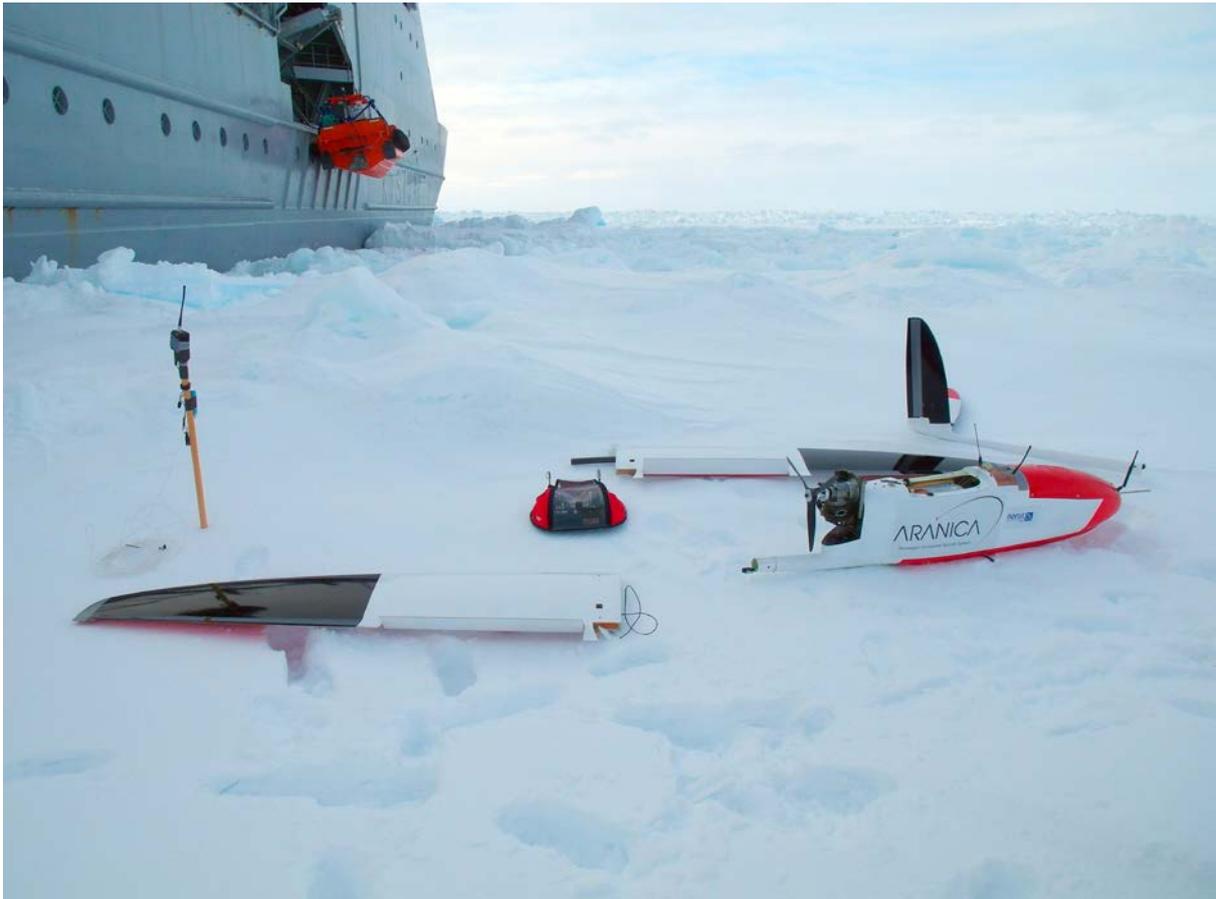
**Figure 14.** CW1 disassembled and ready to be packed in a container and picked up by the ship. Photo: M. Poltermann
