# CRUISE REPORT 2022106

## MAREANO methods cruise: AUV testing (Munin +)

TOKTRAPPORT  
No.6 2023

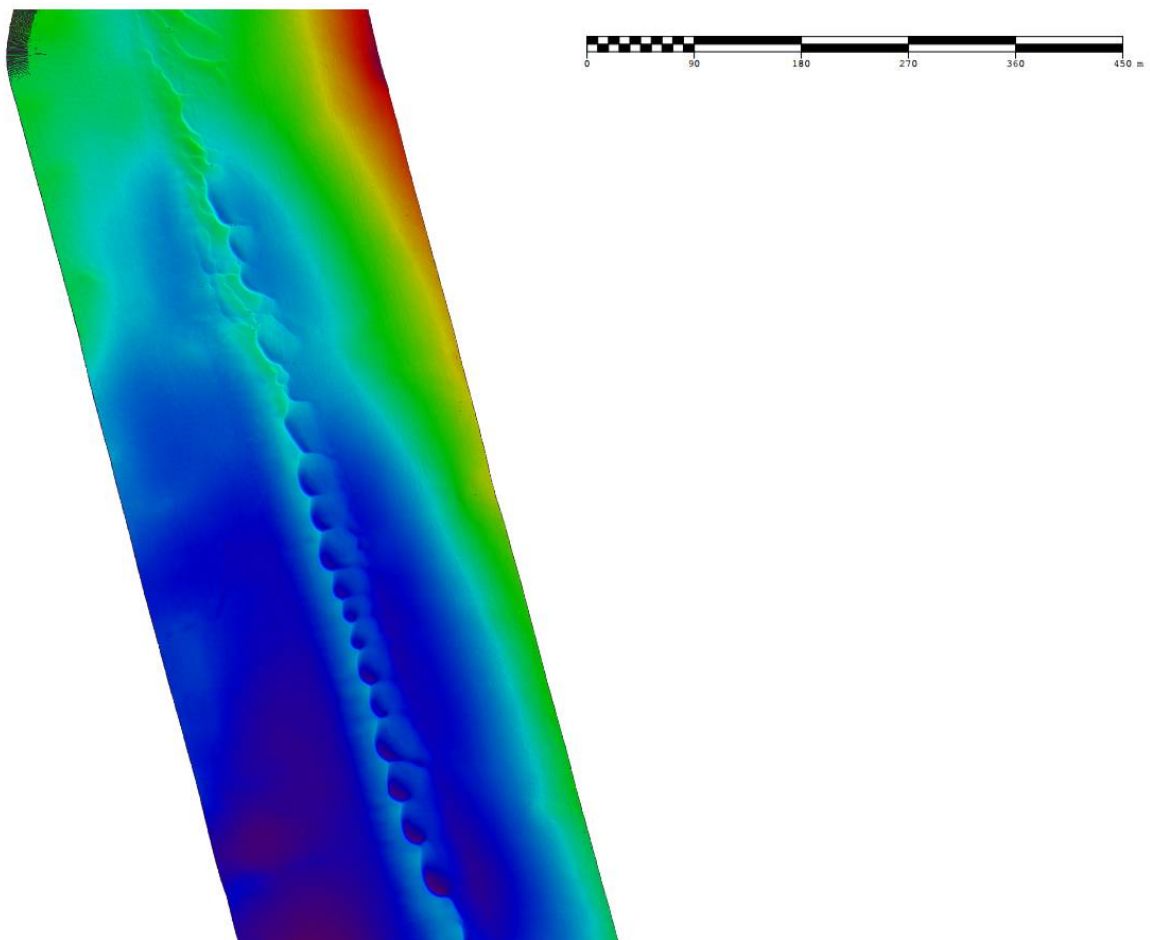
*Image shows multibeam bathymetry from AUV Møre (Mission 55 20220606 2) and the sand wave feature at the start of the dive, processed in Caris by Tor Jan Meek.*

At the Tromsø test site there was an issue with an average 20cm difference in depth between overlapping swaths, with the photo lines (up /down slope) showing 20-50cm discrepancy. However this seems to have resolved at subsequent sites without any action taken. Apart from the problems at the Tromsø test site, the MBE data so far has been of very good quality. The MBE data from Mørebanken is much more consistent and of very good quality. Hardly any noise, just a few outliers which is expected, but no “real noise”, no visible sound velocity error, no visible position drift and less than 10cm depth difference between survey lines.

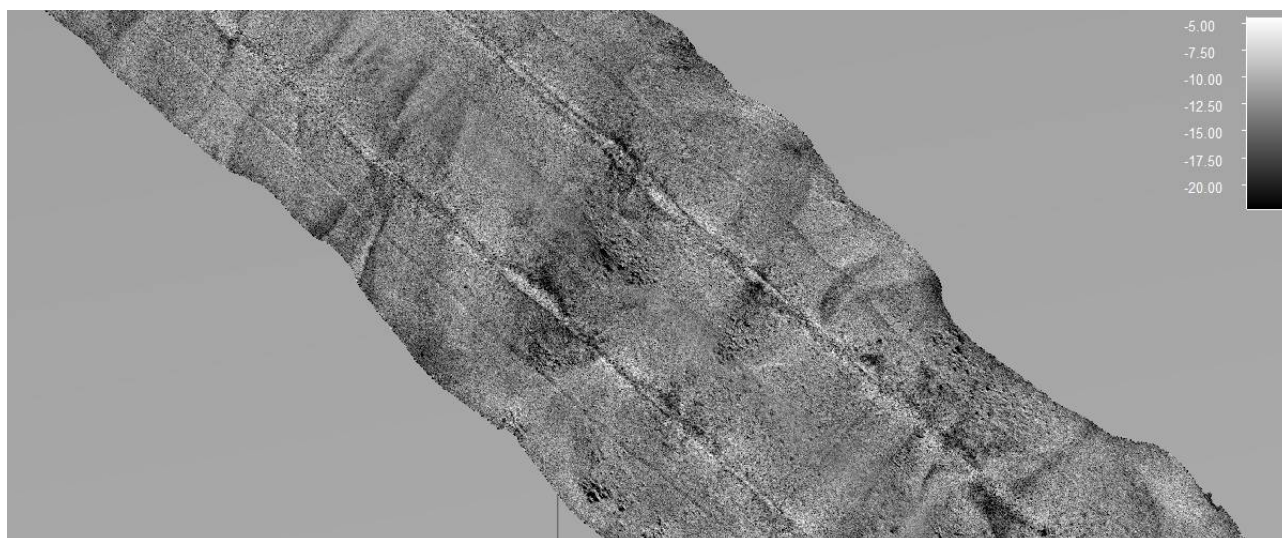
*Example NGU processed backscatter data (FMGT) from AUV Møre\_VL1293 (Mission 55 20220606) showing along track striping (sector problems?)*

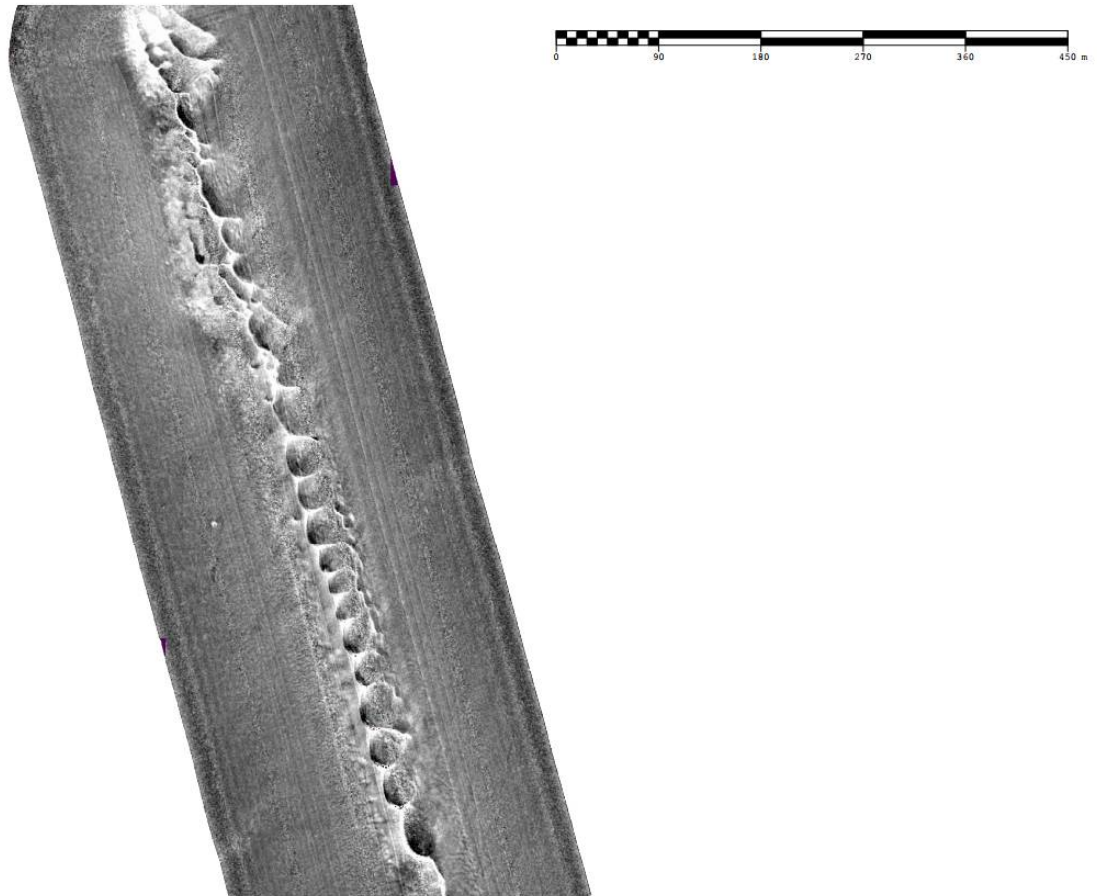
*Example Kartverket (CARIS) processed backscatter from AUV Møre (Mission 55 20220606 2) and the sand wave feature at the start of the dive*

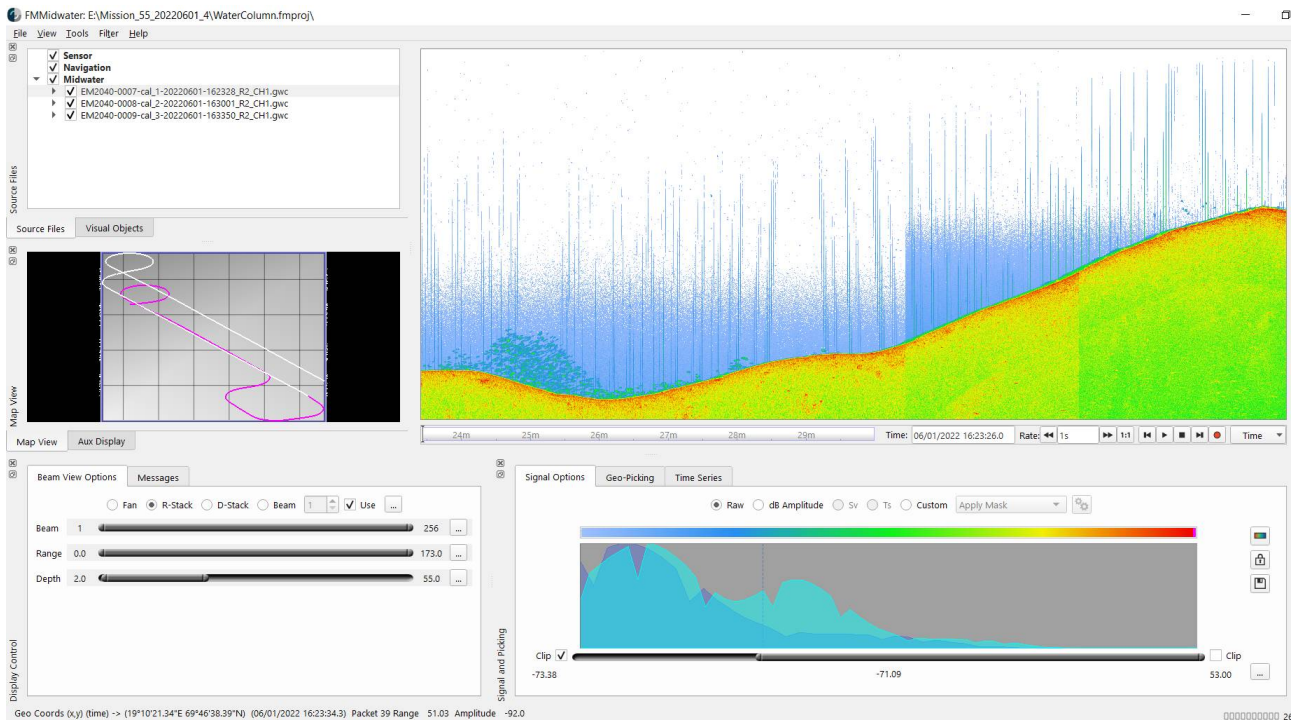
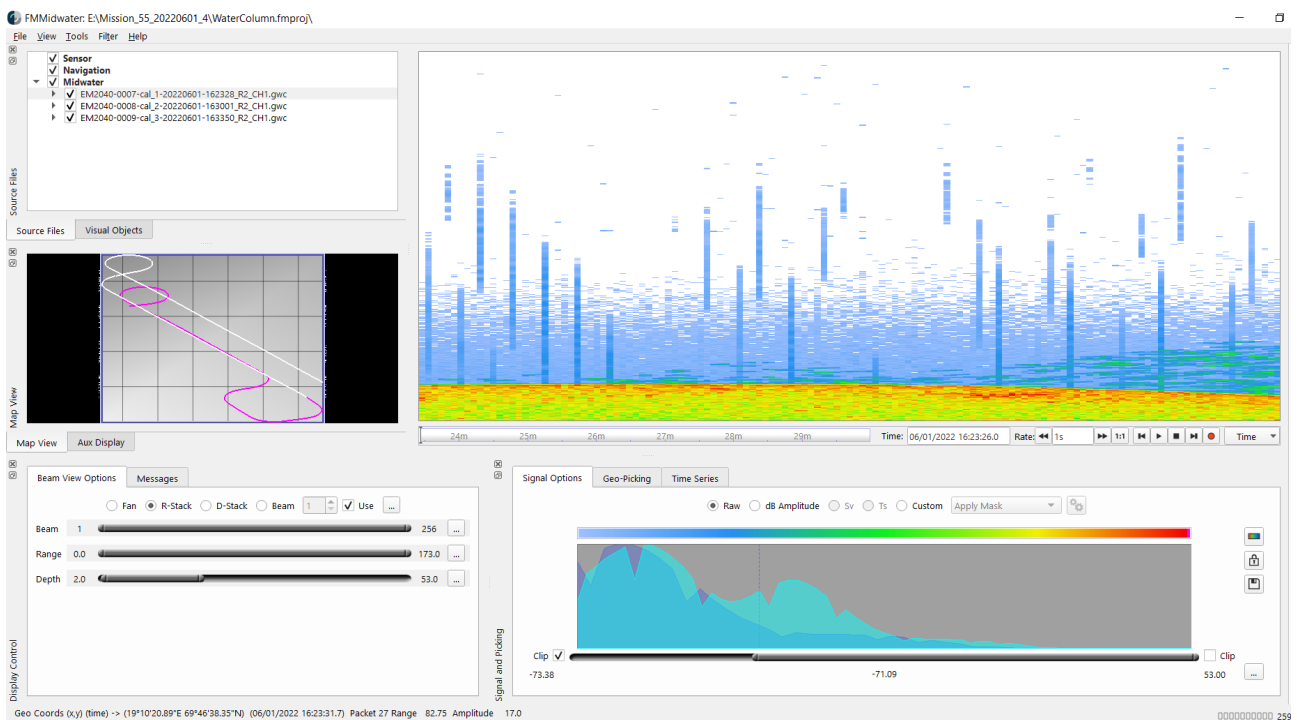
Example data from test area Tromsø – noise appears as vertical striping.

Water column data is fine but interference from other systems were noticed. More testing is needed to single out the noise sources and efficiently avoid them.

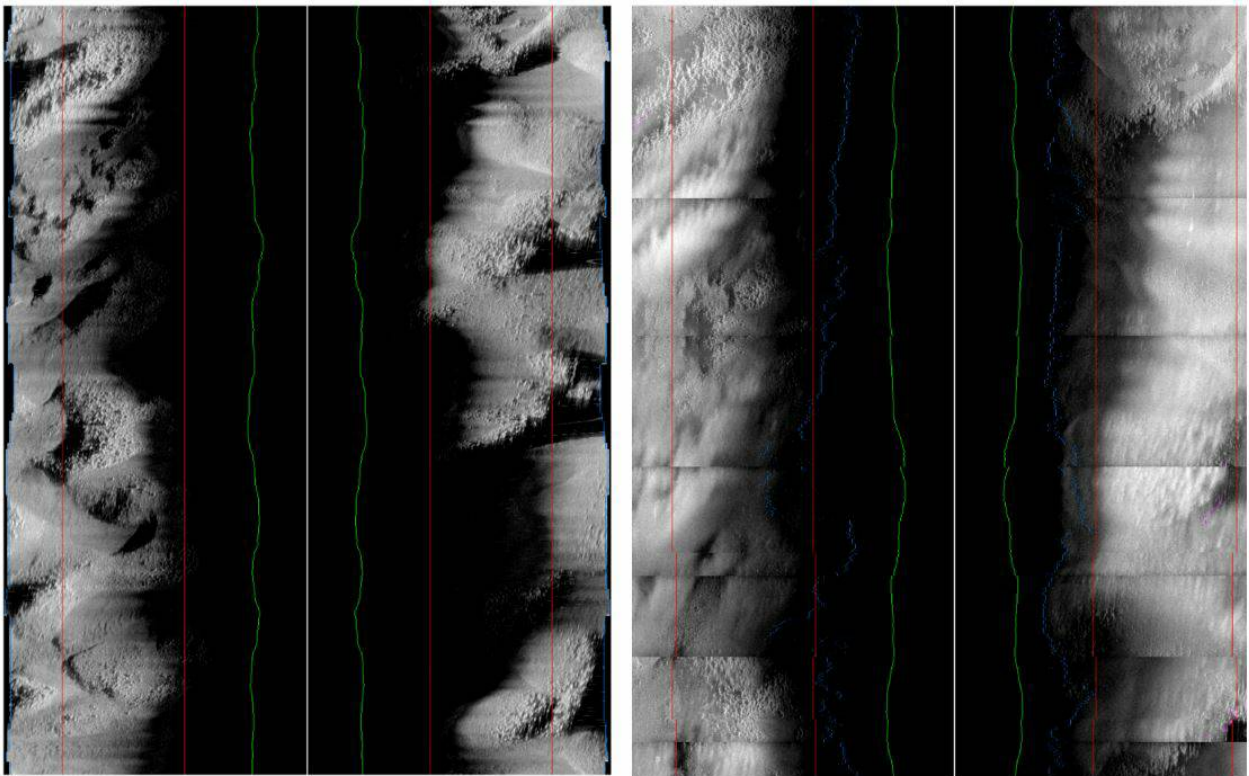
*Comparison between the “sss” (left) and “HiSAS imagery” (right). The resolution of the sss-data is low, but the data is consistent, while the resolution of the HiSAS is high but the consistency is poor.*

The HiSAS imagery as seen after the on-board processing was not as good as expected. The processing algorithm seemed to struggle to display the data correctly in the Reflection software. As seen on the figure, the resolution of the data is impressive, but the dataset is severely obscured by some sort of artificial striping perpendicular to the flying direction. The sharp stripes occur on the border between the individual sas-files (each <100 MB), but blurry lines are related to the processing algorithm. Part of the reason of this is believed to be a software issue and it is believed that the quality of the data will be much better after proper processing, but it is likely that as we gain more experience and are able to plan HiSAS surveys in more detail that this will also improve the results. The HiSAS processing algorithm favours a flat seabed, and the instrument is very susceptible to “pitch” and “crab”.

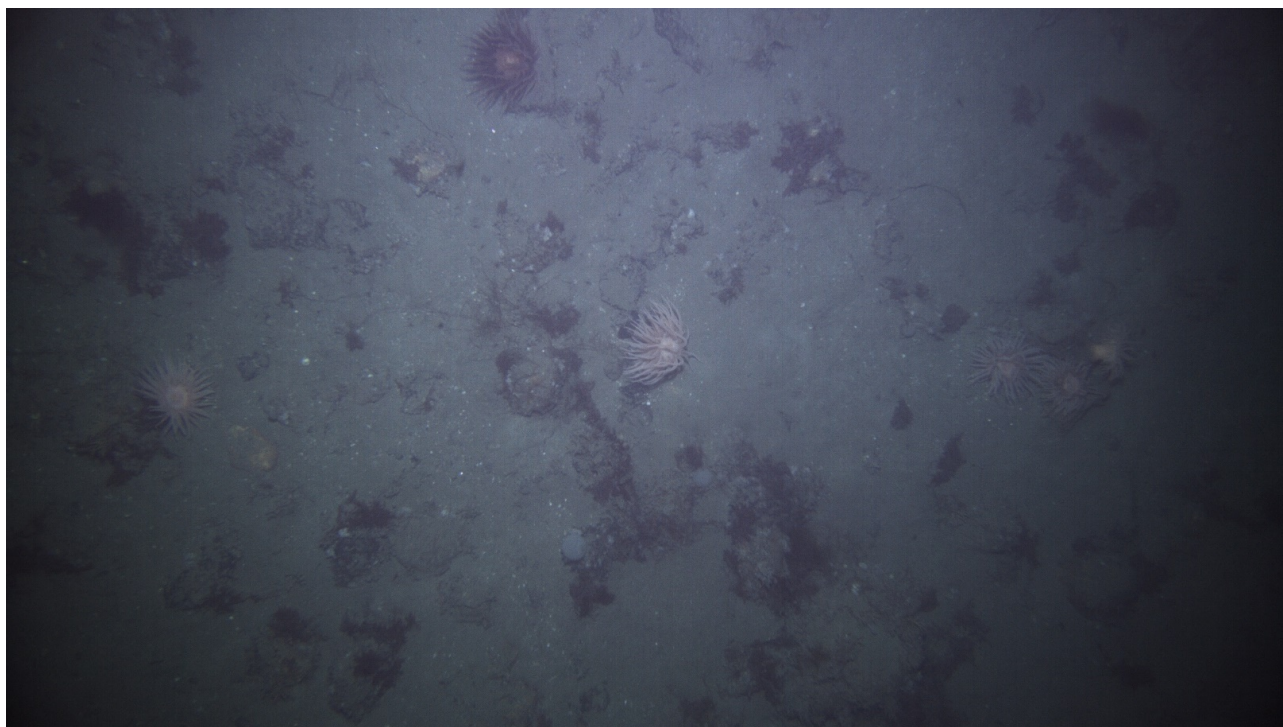
*Example photo from 5m altitude at the test site (unedited)*

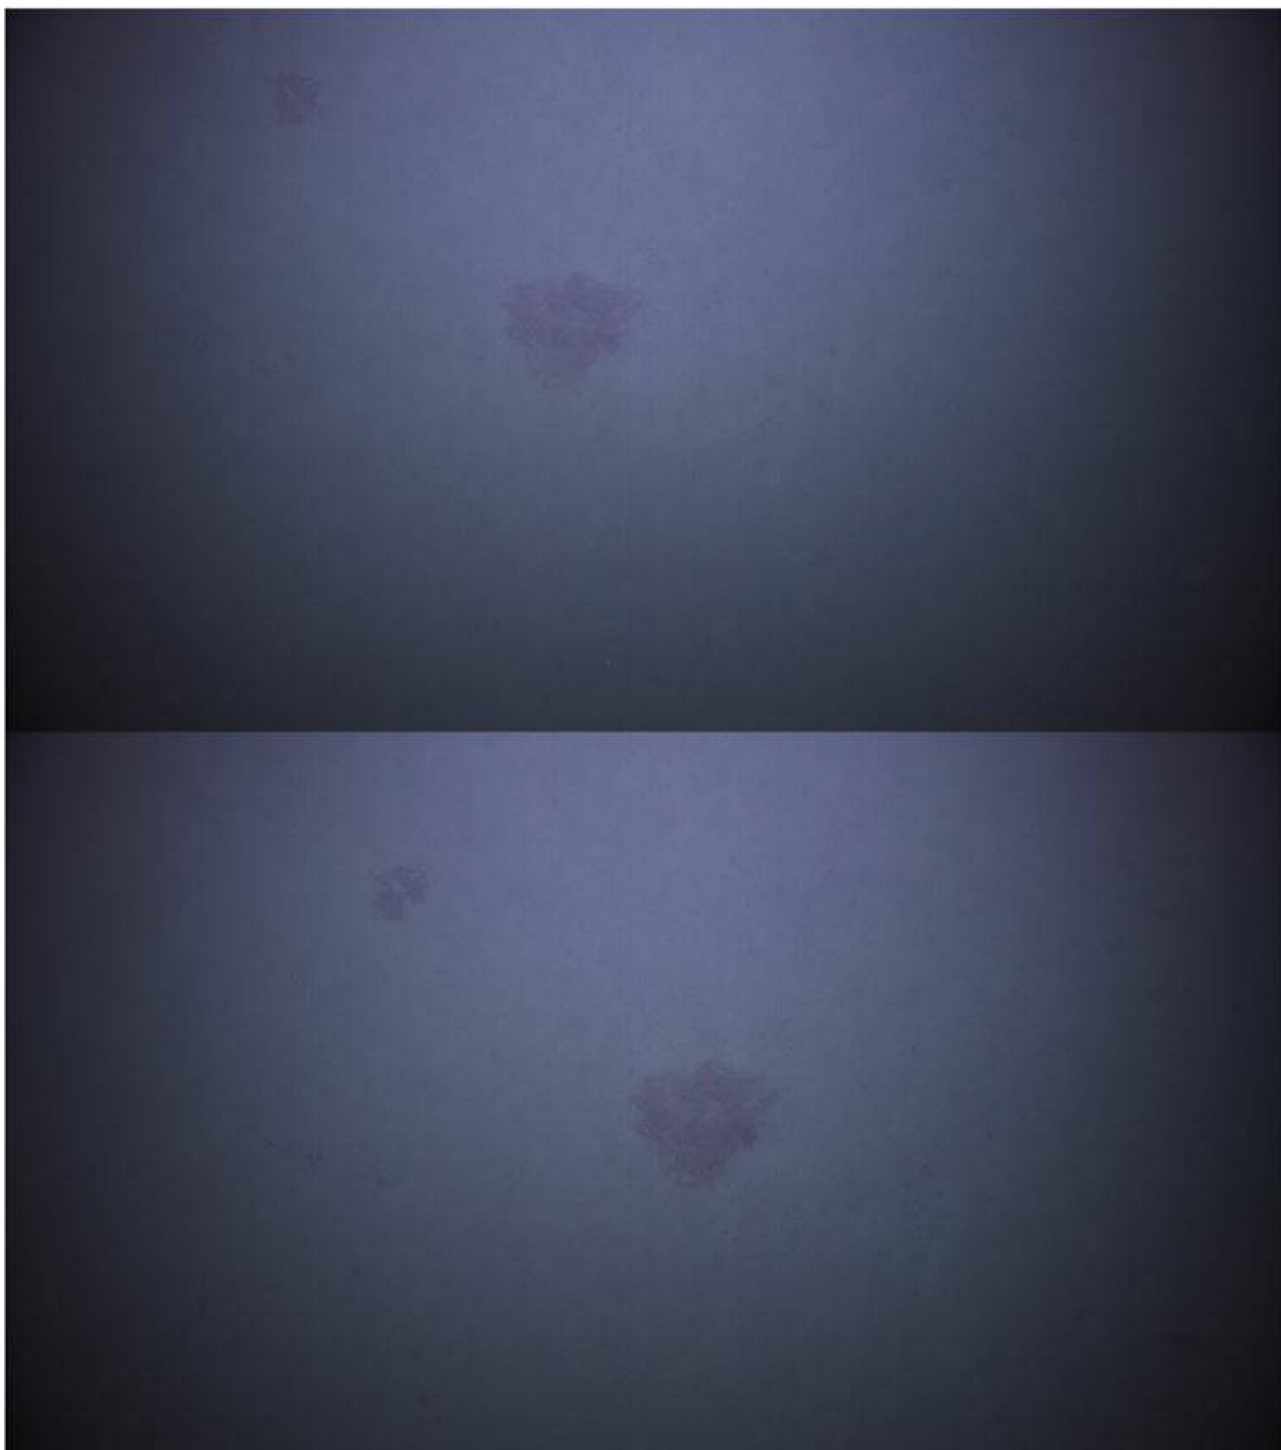
*Example photos from the AUV: testing heights - a discarded chain at the test site is visible in both 6m (top) and 5m altitude photos (bottom) – both are unedited.*

Photo lines have been tested successfully at 6m, 5m and 4m altitude, although note that despite having 4m altitude set at AUVMøre the rough terrain of the coral reef on a slope meant that the AUV did get to within 2.6m of the bottom at one point before recovering and re-gaining the programmed 4m altitude. Lower altitudes are therefore not recommended on rough terrain, but could be possible on flat sediment bottoms.

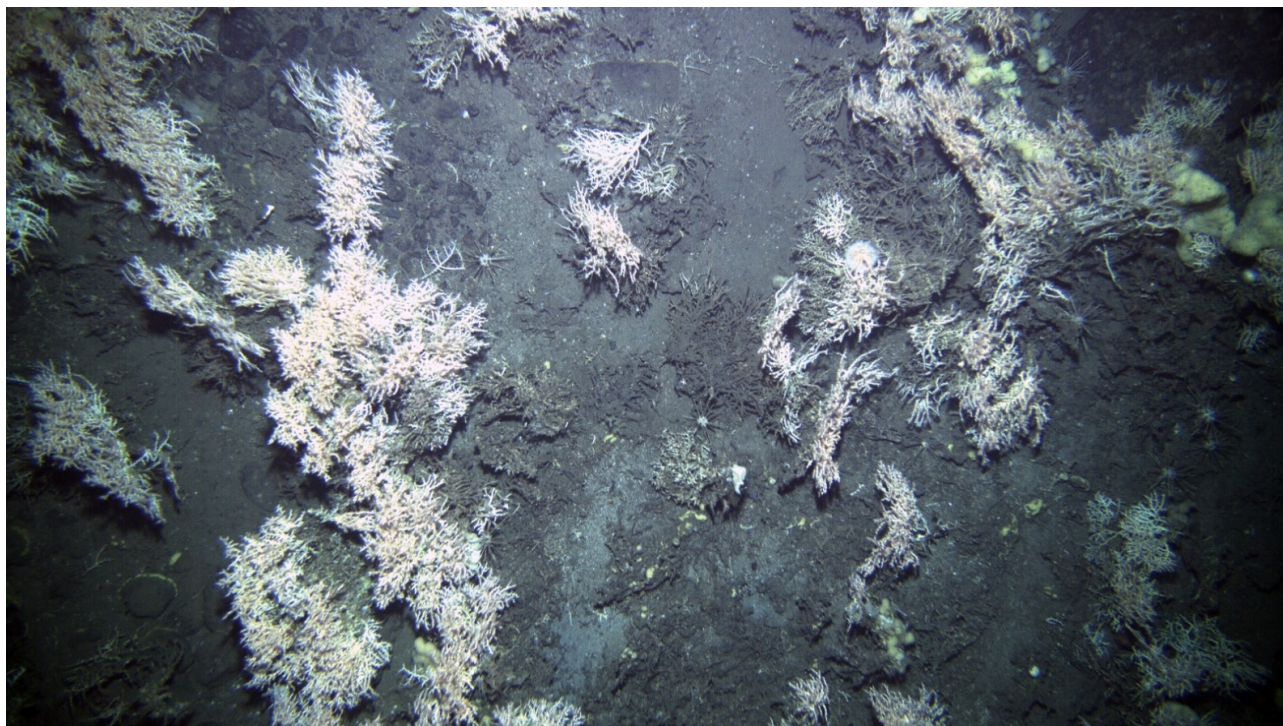
*Photo from AUV Møre taken from an altitude of 4m over a coral reef (includes some colour corrections)*

The successful AUV møre reef photos were taken at 4m altitude on the downslope. The same VL was attempted first in an upslope direction (again with 4m altitude programmed) but the terrain avoidance measures, coupled with an over cautious "safe height" resulted in most images being taken at 8-10m off bottom which is confirmed too high to be of use.

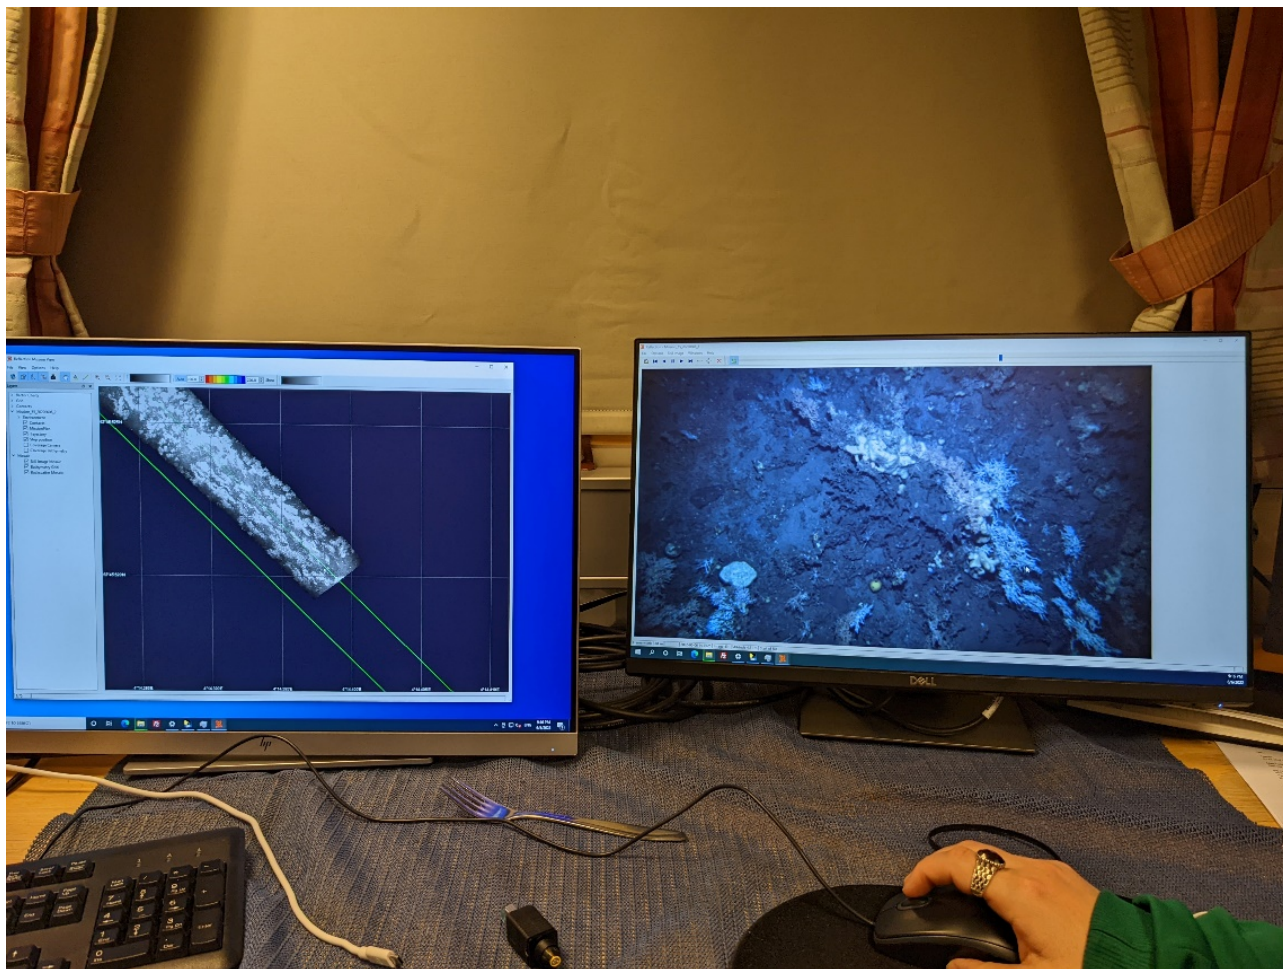
*View of reflection software showing a photomosaic of images plotting on the downhill pass of the photoline1293 at AUV Møre.*

View of photomosaics in the Reflection software is possible had some success (see screenshot below). Reflection plots the images one by one in sequence and shows how they overlap (you must wait for this process to finish to see the photomosaic of the desired line/area). Exporting photomosaics must be done at low resolution, in black and white and with a limit to what number of images can be included in each saved file (seemed like ~100m of straight line could be saved in one go with 1cm resolution. Investigations are ongoing as to whether a 3<sup>rd</sup> party software can improve outputs with colour photomosaics preferable if possible.

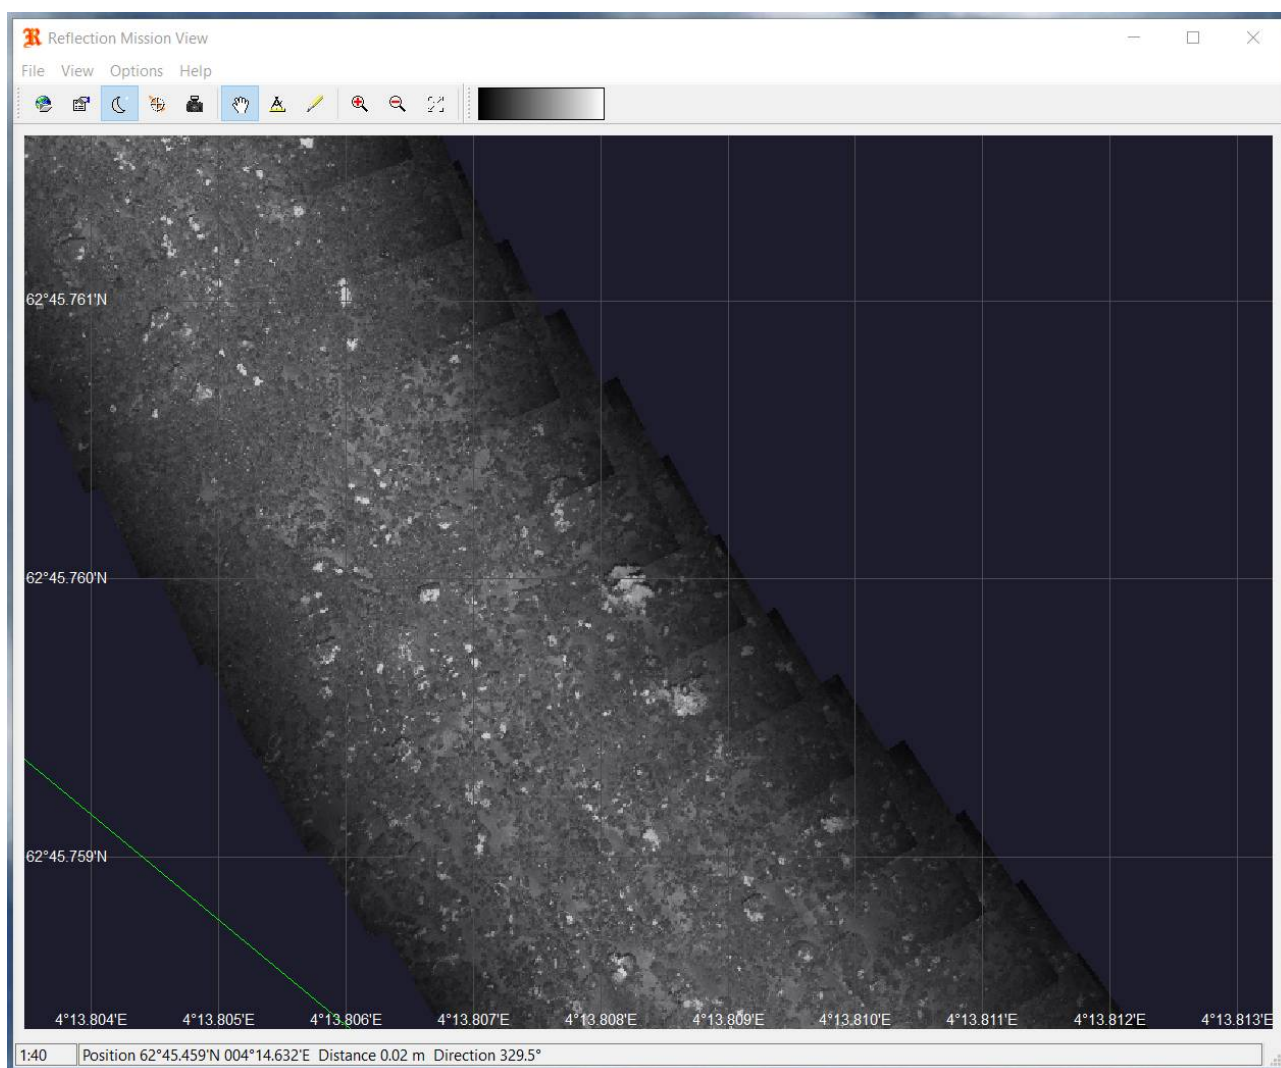
*Example of photo mosaic at 1cm resolution from the 4m altitude downhill run at photoline1293 at AUVmøre, white marks are sponges and corals. Note that averaging must be switched on in "Still Image Mosaic Options" otherwise the image will blur with slightly misaligned images.*

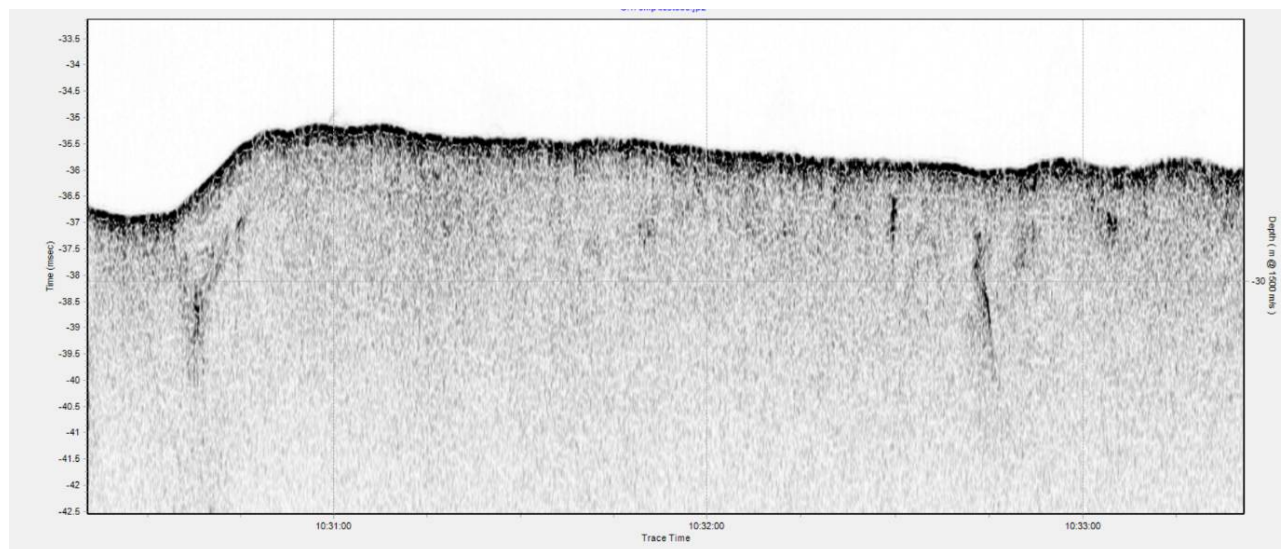
*Example sub bottom profiler data from AUVMøre VL1071*

SBP data looks fine, but the areas investigated do not have much stratigraphy to check the penetration capabilities. Further testing is necessary.

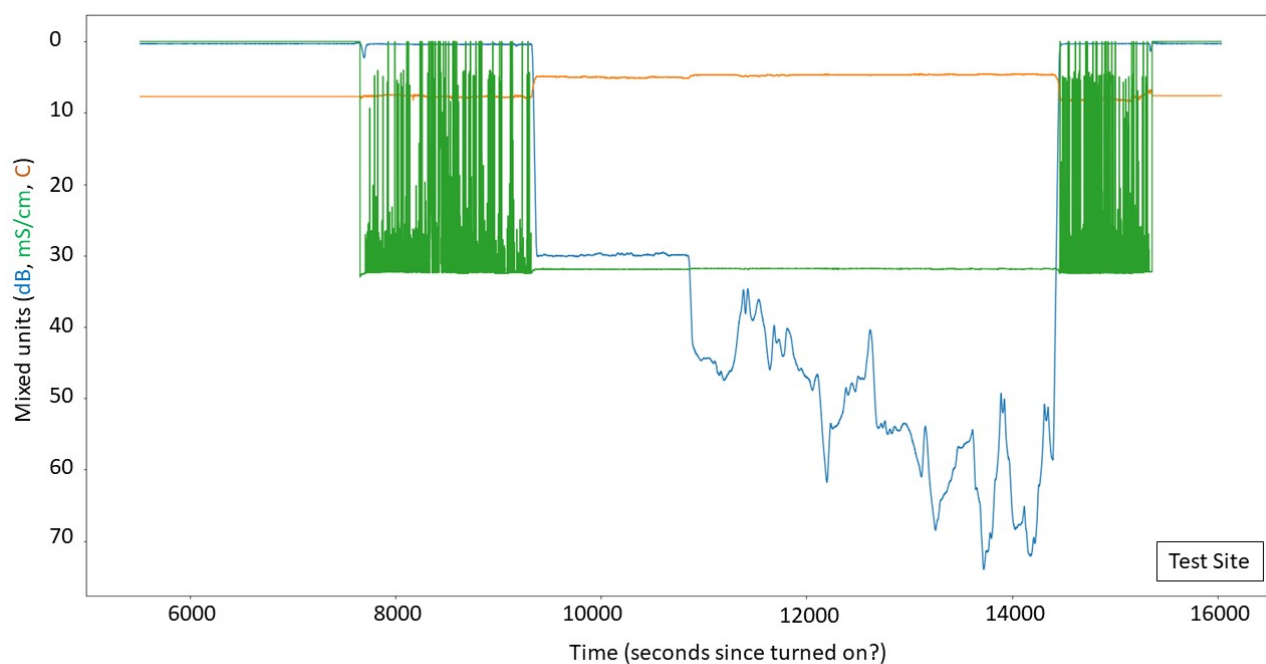
Overview CTD graph from the test site: Blue line: pressure (dB), green line: conductivity (mS/cm), orange line: temperature (C). The units are not specified in the files and are to be considered as reasonable assumptions. The x-axis is time, in mystery units. It might fit with seconds since the AUV was turned on. The "forests" in the conductivity data corresponds to time the AUV was spending in the sea, but on the surface, where the CT sensor was bobbing in and out of the water.

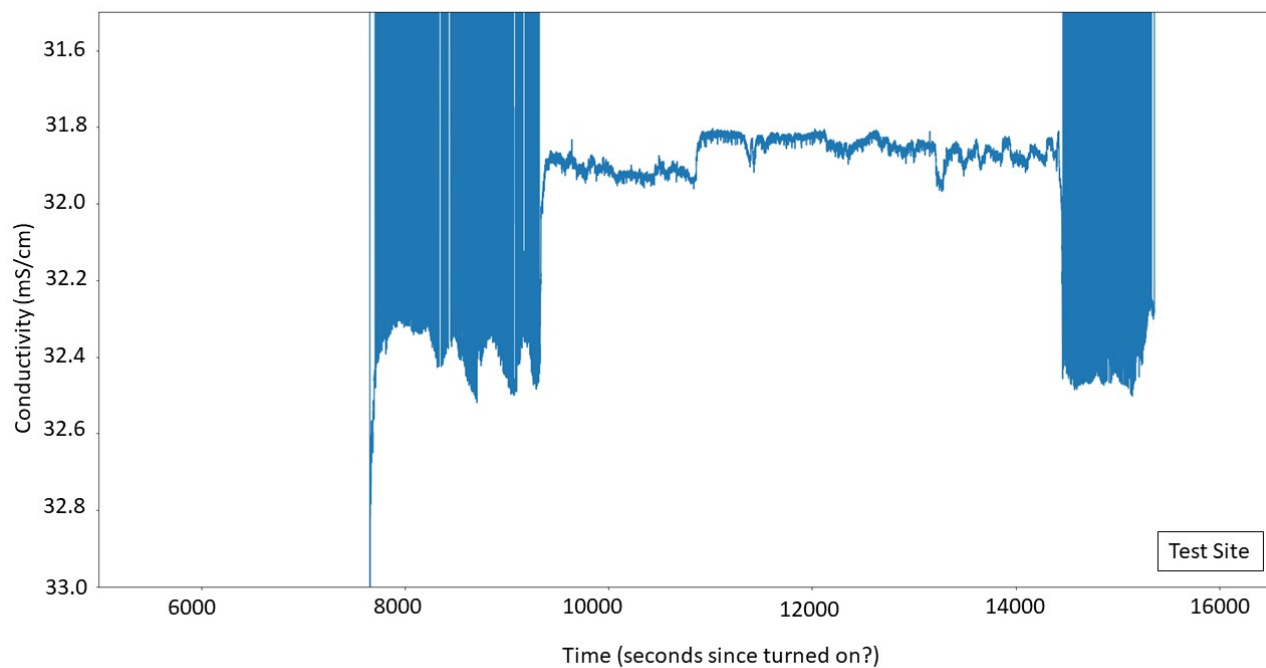
Conductivity versus time, zoomed in to show variation.

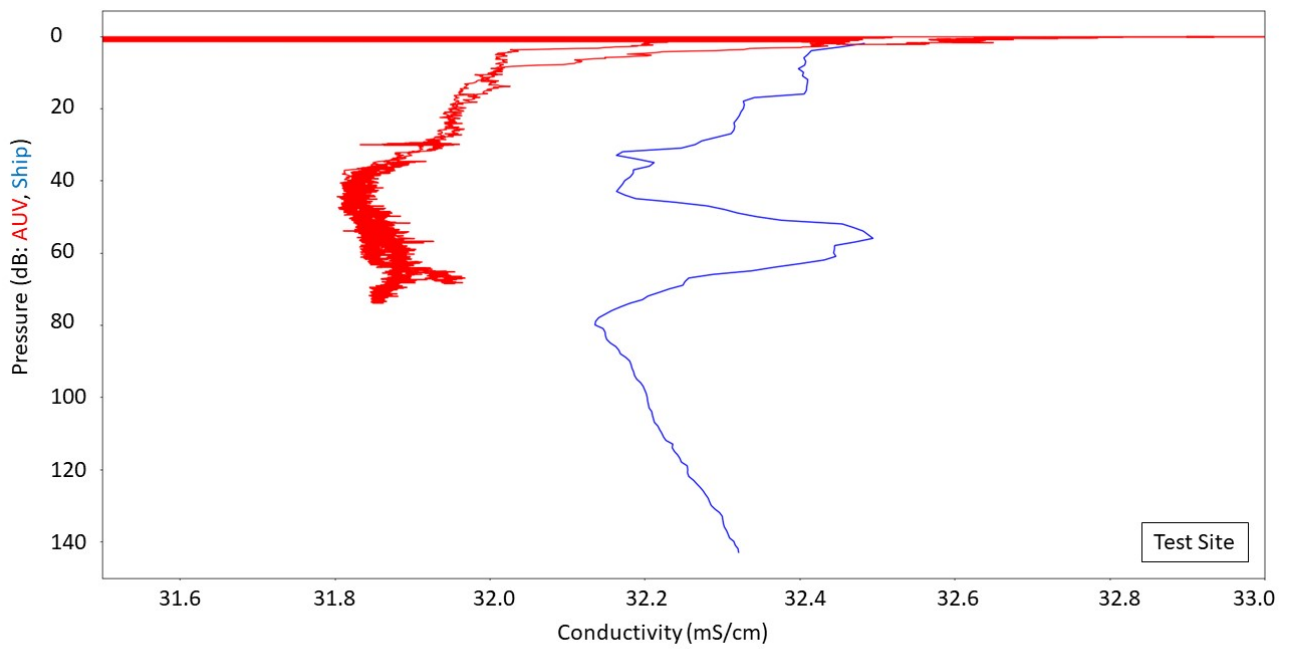
Comparison between shipborne and AUV conductivity. The shipborne CTD was taken in a deeper area slightly off the site. The ship CTD uses S/m units of conductivity – these have been multiplied with 10 to match the units from the AUV. The most glaring difference is an offset of about 1%. In the upper part of the water column, the profiles otherwise reproduce the general shape of the profile, and the spike at 30m depth. The thick part of the AUV graph corresponds to the AUV moving near the bottom, covering an extended area with varying depth. The shape of the profile here does not match that of the shipborne CTD well, but since the AUV test area is in a strait and, and the CTD station in deeper water, this might be due to real differences in the water properties.

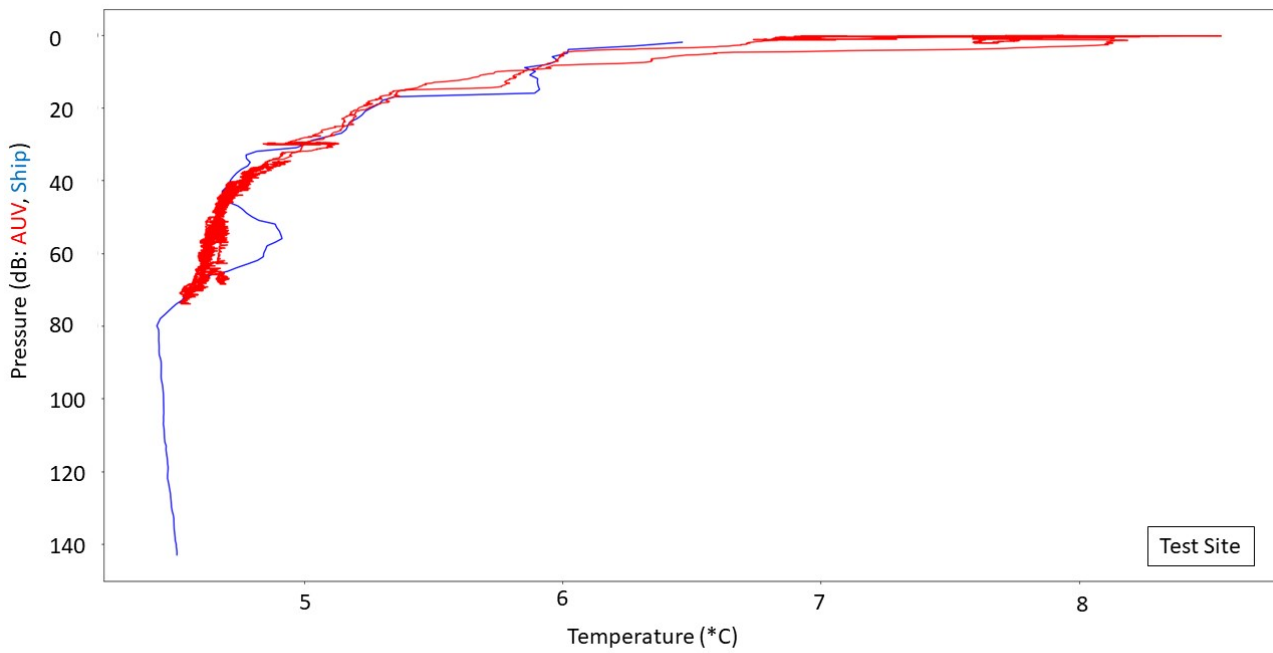
*Comparison between shipborne and AUV temperature. The shipborne CTD was taken in a deeper area slightly off the site. Overall, the match is reasonable in the upper part of the water column. The feature in the shipborne CTD at 45-70m is not reproduced in the temperature profile either, but more resembles the AUV conductivity profile above. While the cause is unknown, it lends support to the hypothesis that the water properties really are different in the shallow and deeper areas.*

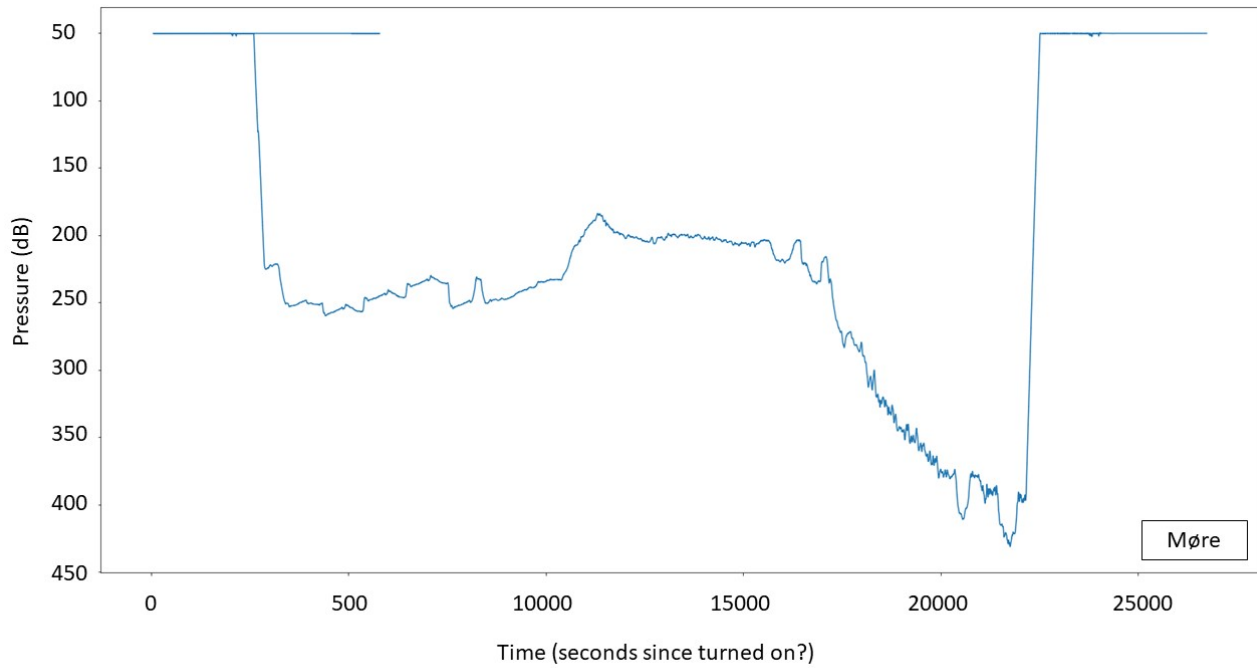
*Depth (pressure) over time. The AUV was deployed on the shelf and did a couple of “mow the lawn” areas on the shelf before transiting down the slope to the final “mow the lawn” at a deeper level.*

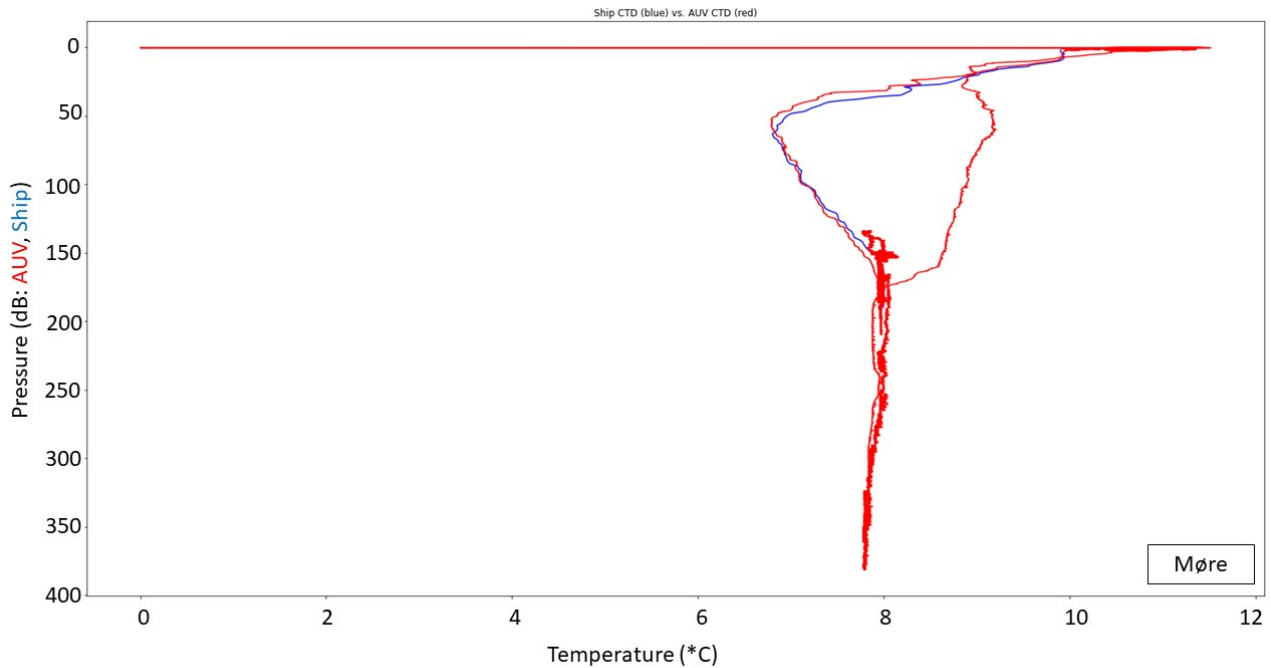
*Comparison between ship and AUV temperature. The downcasts follow each other well, but it is possible that there is a small offset of some kind. It is also possible the difference is due to natural variation and a (small) difference in position and time of the two casts.*

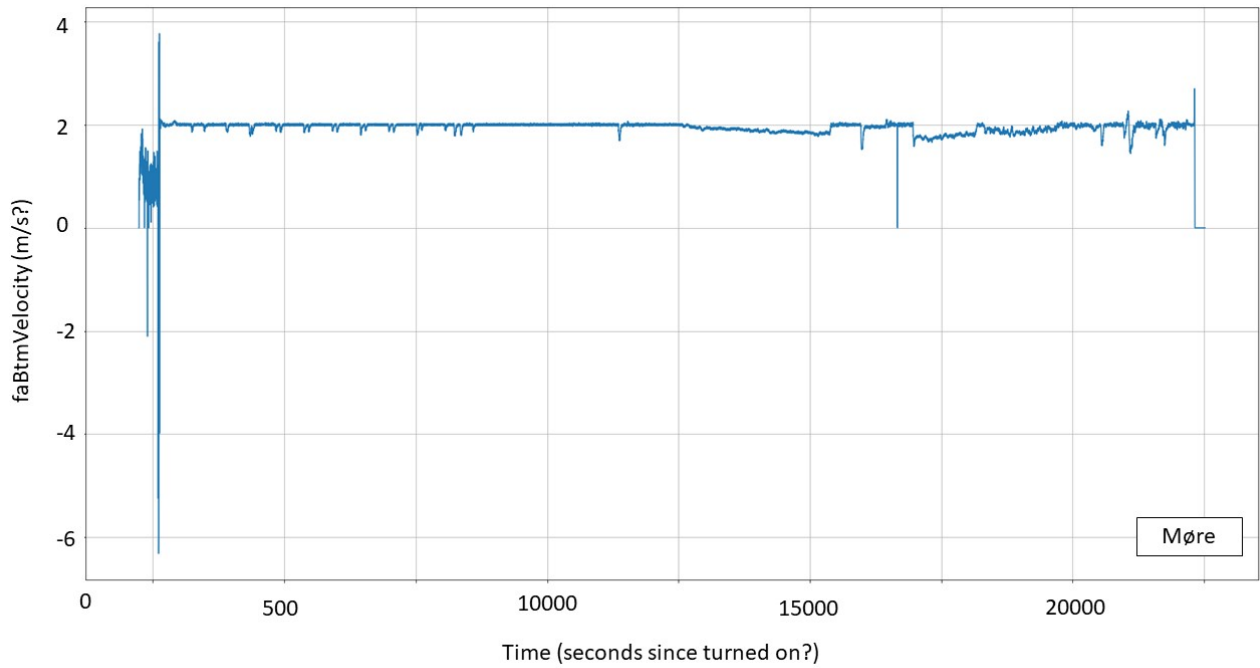
*faBtmVelocity vs. time, assumed to be the bottom track velocity in the along-AUV direction. The velocity of about 2m/s(?) corresponds to the AUV speed of 4kn.*

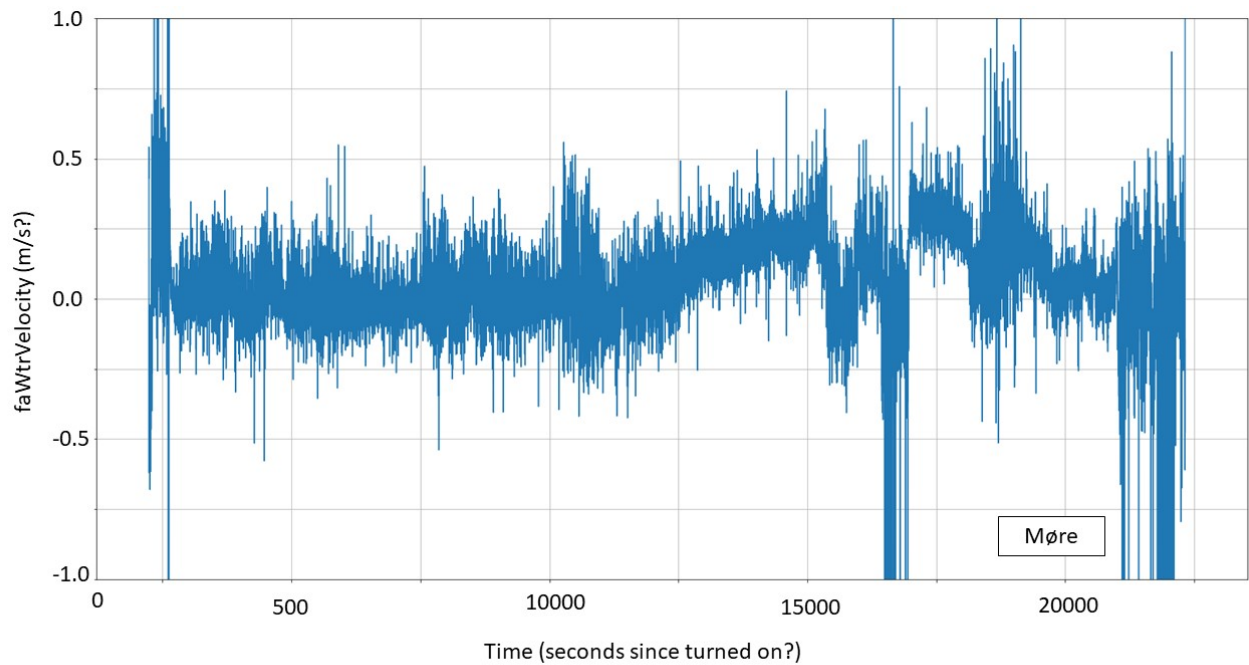
*The parameter faWtrVelocity, assumed to be speed through water in the along-AUV direction, is very similar to faBtmVelocity. Subtracting faBtmVelocity from faWtrVelocity gives the above plot, with residual velocities. The magnitude of the residual current is within expectations from the shelf slope (up to ~0.70 m/s).*

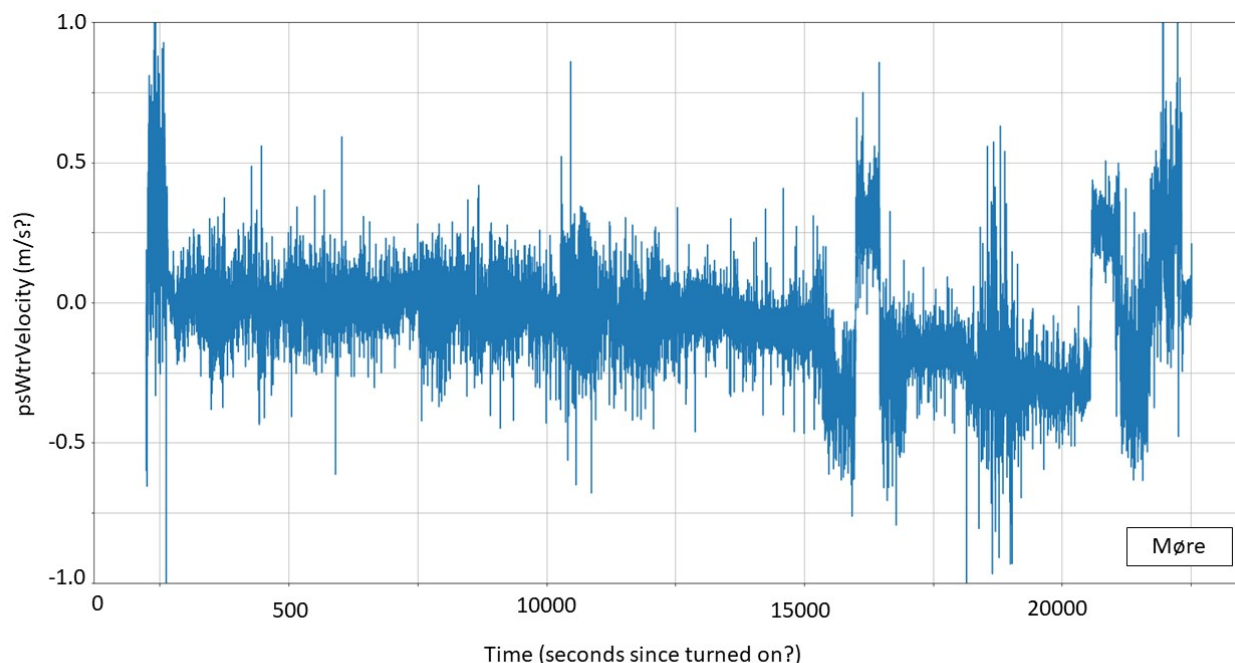
*Above plot is  $psWtrVelocity - psBtmVelocity$  (i.e. residual currents in the cross AUV direction). Again the magnitude of the current is plausible. The AUV descended the slope at an angle, so we would expect the slope current to be split between along- and across-AUV directions.*

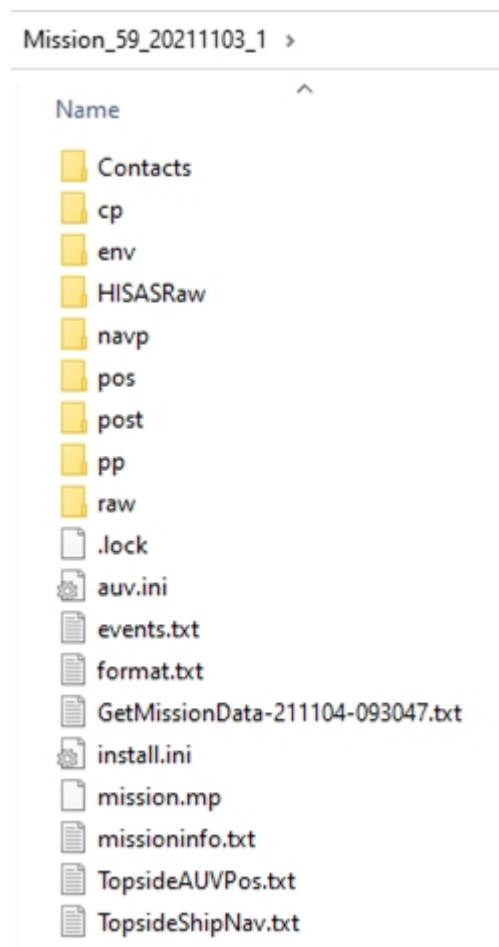
*screenshot of a typical mission folder structure*

NB The format file is useful for finding headers for any of the sensor data.
