# CRUISE REPORT 2022106

## MAREANO methods cruise: AUV testing (Munin +)

TOKTRAPPORT  
No.6 2023

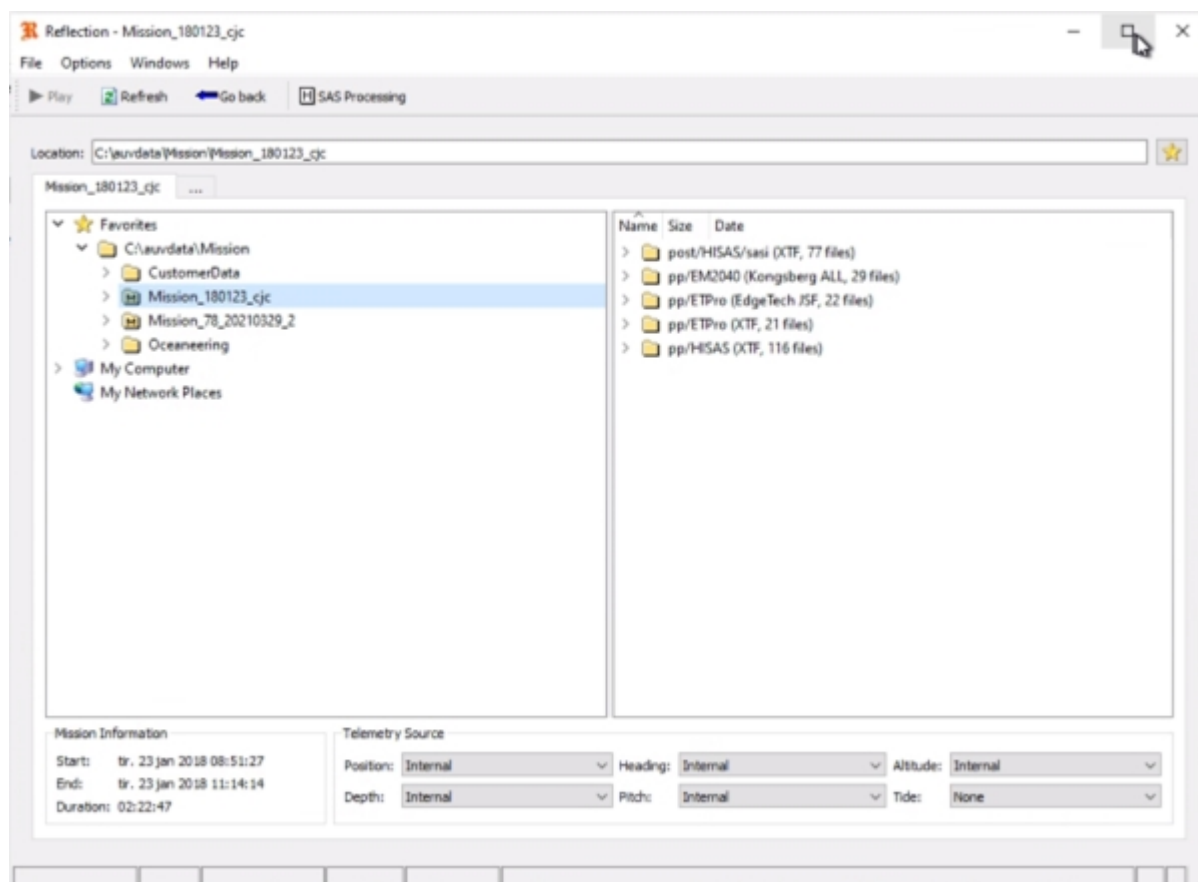
*Screenshot of Reflection's file selection window - the start point when trying to view AUV data*

Within subfolders you can select file to visualise and you can use the dropdown menus at the bottom to modify various options e.g. whether you used processed or unprocessed navigation data. You will then press play to view the data and are automatically shown the right type of viewer for that data.

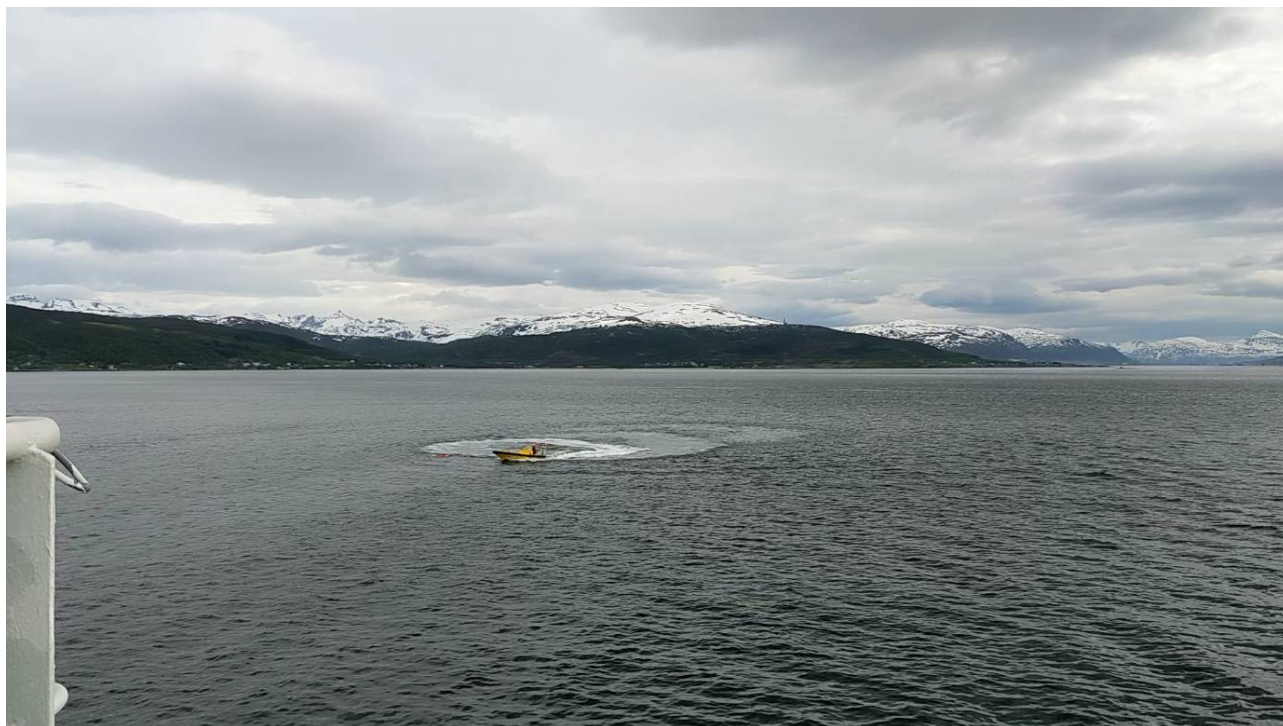
*MOB boat doing circles around the AUV. Photo R Ross*

- **Currently the Munin+ will not be able to dive if the conditions are too calm**. We used the MOB boat to run circles around the Munin+ in order to make enough waves to allow it to tip beneath the surface. This will hopefully be rectified before future work, Kongsberg have already suggested a new propeller to address this.

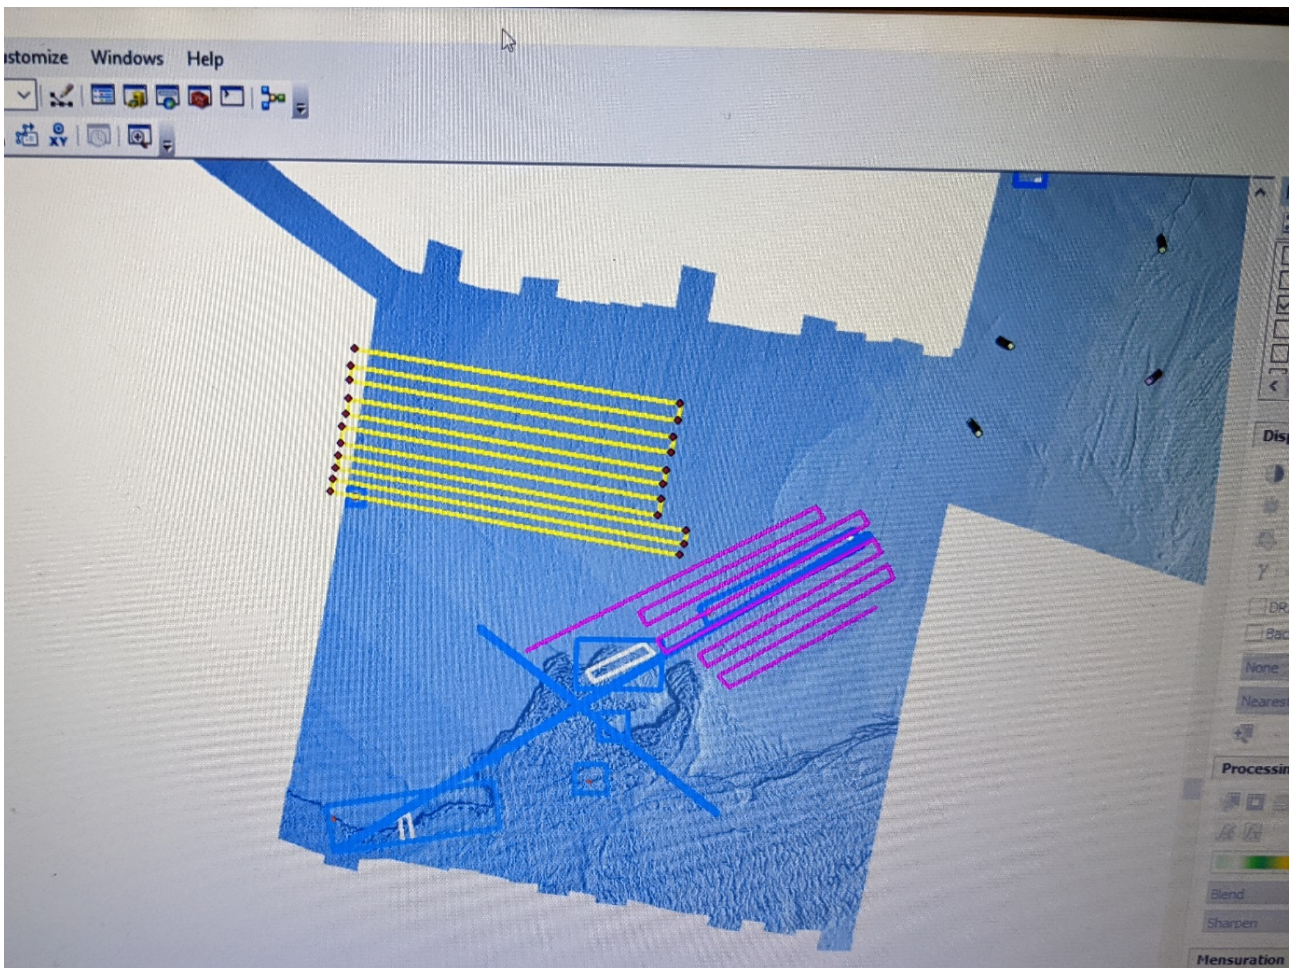
*Planned SBP/WC MBE surveys in pink (the first) and yellow (the second)*

Shyam had recently designed a survey pattern for use at night to acquire sub-bottom profiler and water column MBE data more densely around pockmark fields within BO1, so we began at kl. 09:35 with this surface vessel based acoustic survey instead of doing the AUV dives. Once this had begun it became clear that water column data was likely to be too bad, so that was only collected on the first line, and then tested again later on. Sub-bottom data looked acceptable, particularly when driving SW to NE with the wind behind the vessel, although as the wind increased the quality decrease on the NE to SW legs such that we instructed mid-way down the 4<sup>th</sup> line (a NE to SW leg, ~15:40) that the vessel speed back on NE to SW legs and focus on collecting data in the SW to NE direction. This has resulted in every other leg being collected with adequate quality, and the vessel was instructed to return to collect the poor-quality NE to SW legs in a SW to NE direction. After this the vessel will move on to a secondary similar pattern. By 18:50 the wind was beginning to lessen (peaked around 15 m/s, then 10 m/s) so we planned to return to AUV6 in the morning with the hope that we can begin with the first test dive at the start of the shift (kl. 08:00). Most of the team relaxed throughout the day, especially as more challenging conditions left some feeling unwell. Luckily no serious cases of seasickness were reported.

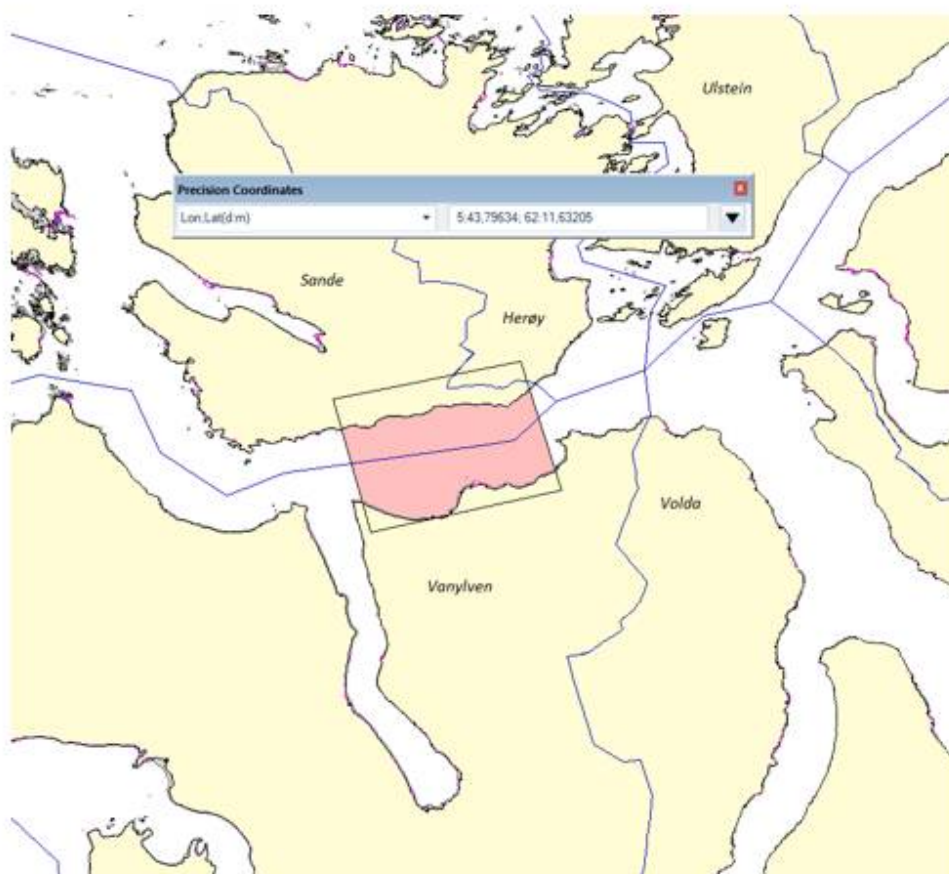
*The second page of the application shows a map of the area we would like to declassify*
